# **INDOOR AIR QUALITY ASSESSMENT**

**Winthrop Elementary School  
162 First Street  
Melrose, Massachusetts**

Prepared by:  
Massachusetts Department of Public Health  
Bureau of Environmental Health Assessment  
August, 2001

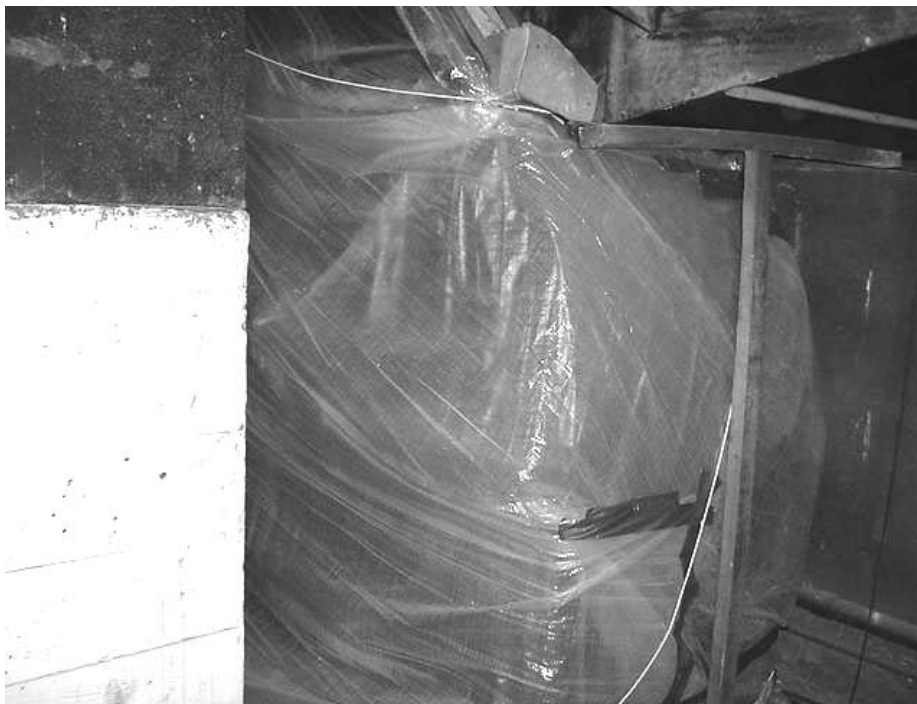
**Picture 3**

Two distinct ventilation systems exist in this building. Fresh air is provided in the 1926 section building by an air handling unit (AHU) located in a large room on the ground floor that is connected to ductwork leading to air diffusers (see Picture 3). Fresh air is drawn into the building through a vent at the rear of the building. Air is drawn through heating elements (see Picture 4) into a fan unit that distributes the air via wall mounted fresh air grilles throughout the 1926 section. Classroom fresh air supply grilles are connected to the fan unit by ductwork located in a crawlspace beneath the 1926

**Fan Unit in Basement**

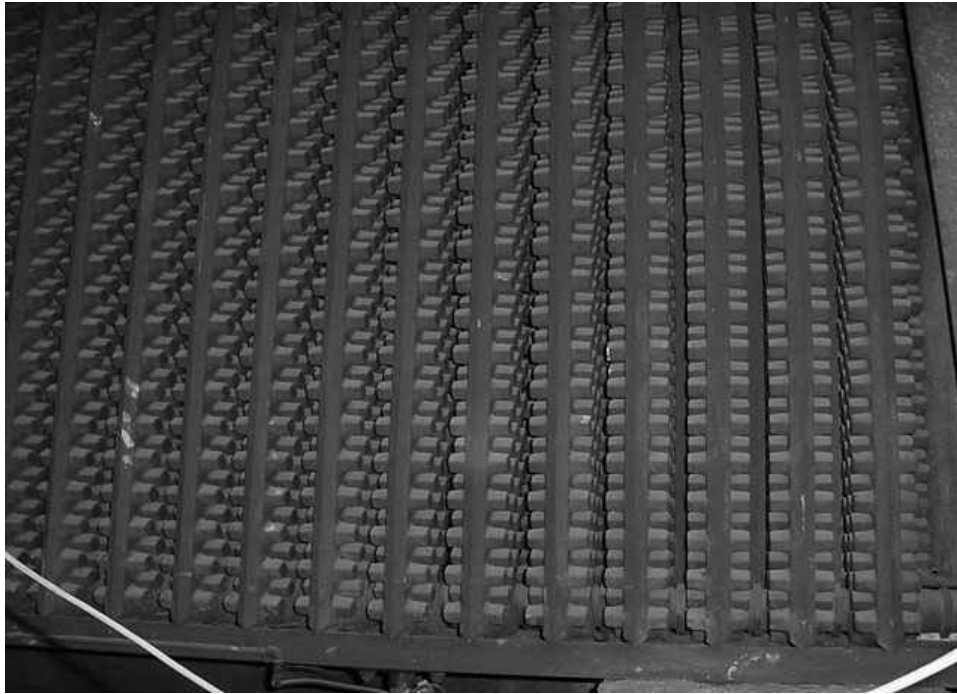
**Picture 4**

**Heating Elements in Basement AHU Room**

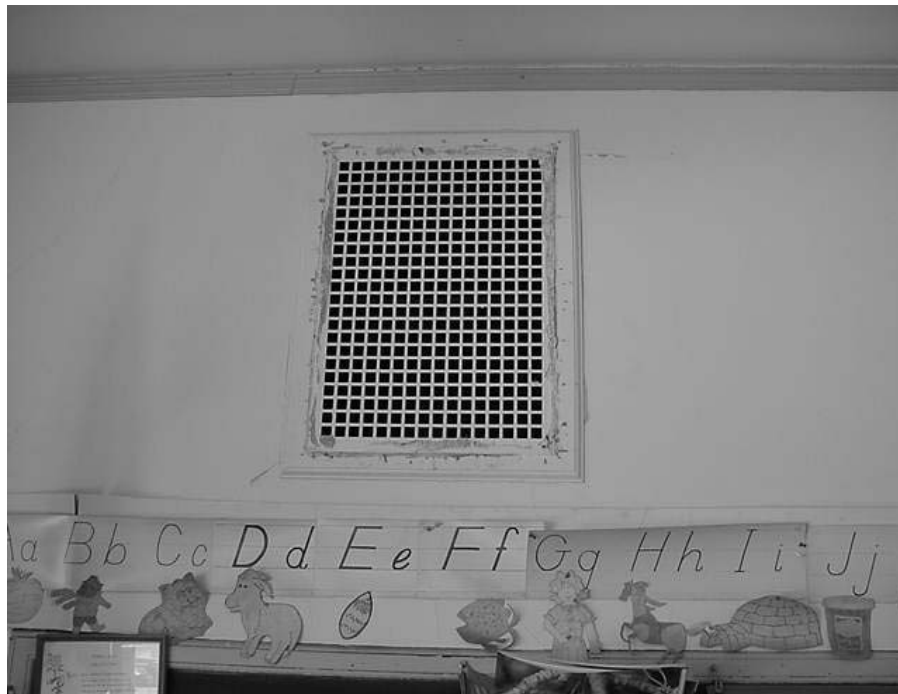
**Picture 5**

1. All fresh air intakes were sealed with plywood (see Picture 5 and 6).
2. The original fresh air intake outside the heating element room was sealed with energy efficient windows (see Picture 7).
3. The air intake for the fan unit that draws air through the heating elements is sealed with plastic (see Picture 8).
4. The fan belt connected to the motor that drives the fan unit was removed (Picture 9).
5. Interior hallway door transoms were removed and sealed with plywood.

**Fresh Air Supply In 1926 Classrooms**

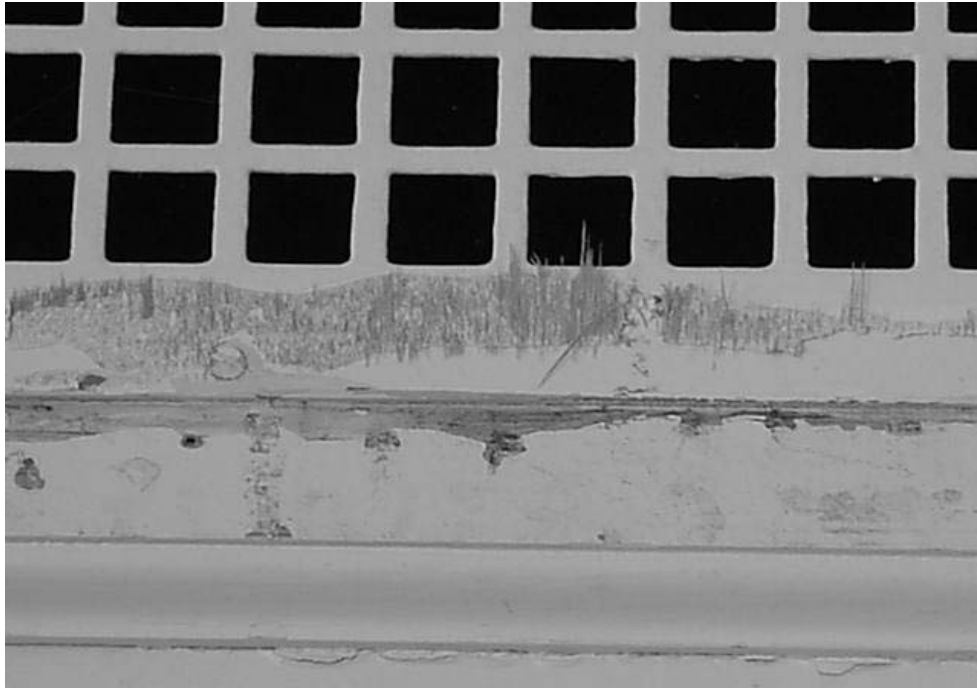
**Picture 6**

**Wood Residue On Fresh Air Intake Frame, Indicating That These Vents Were Sealed With Plywood**

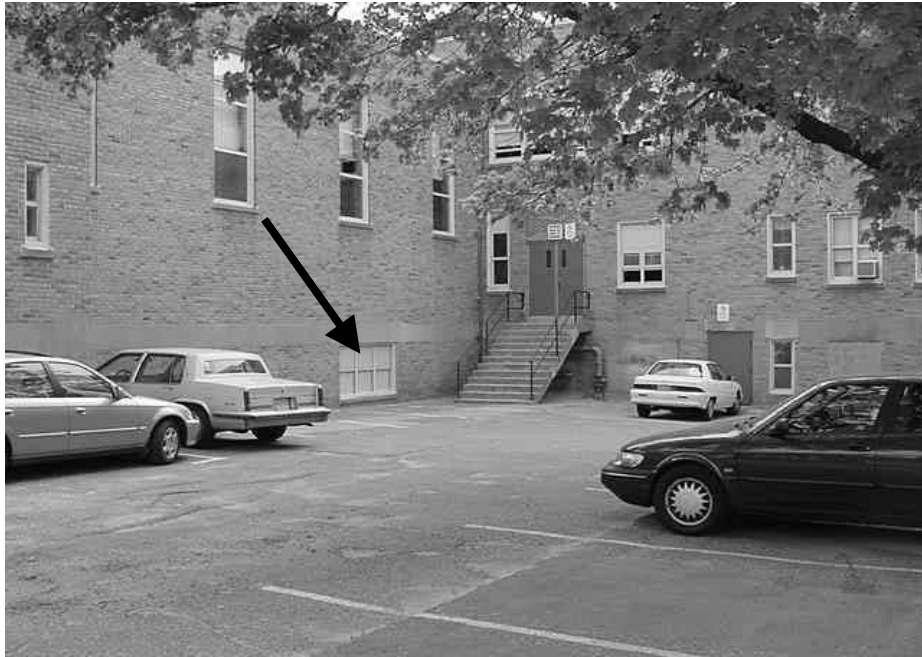
**Picture 7**

**Former Fresh Air Intake Vent for Basement AHU Room, Now Sealed With Energy Efficient Windows.**

7. Use the sash windows in air mixing rooms to introduce fresh air into the building.
8. Use open windows and hallway doors to enhance airflow during warm weather. Be sure to close windows and doors at the end of the school day. To aid in the draw of fresh outdoor air in warm weather, use portable fans directing air out windows on the leeward side of the building. Fans positioned in this manner will serve to increase the draw of outdoor air across a floor without interfering with the natural, internal airflow pattern of the building. To aid cross ventilation, open hallway doors in areas with inoperable transoms.

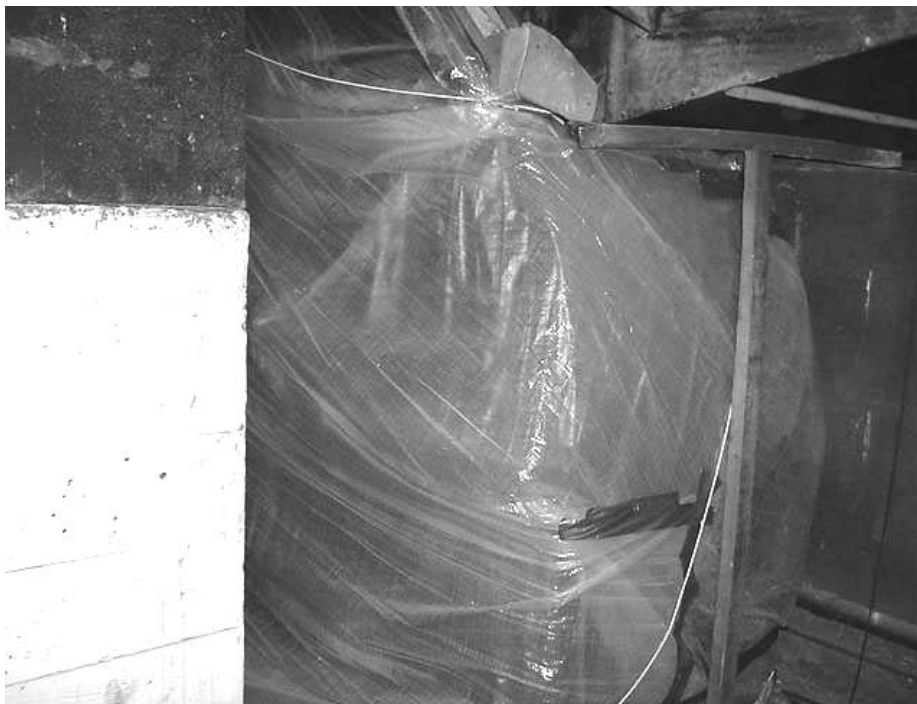
**Picture 8**

**AHU Air Intake Sealed With Plastic Sheets**

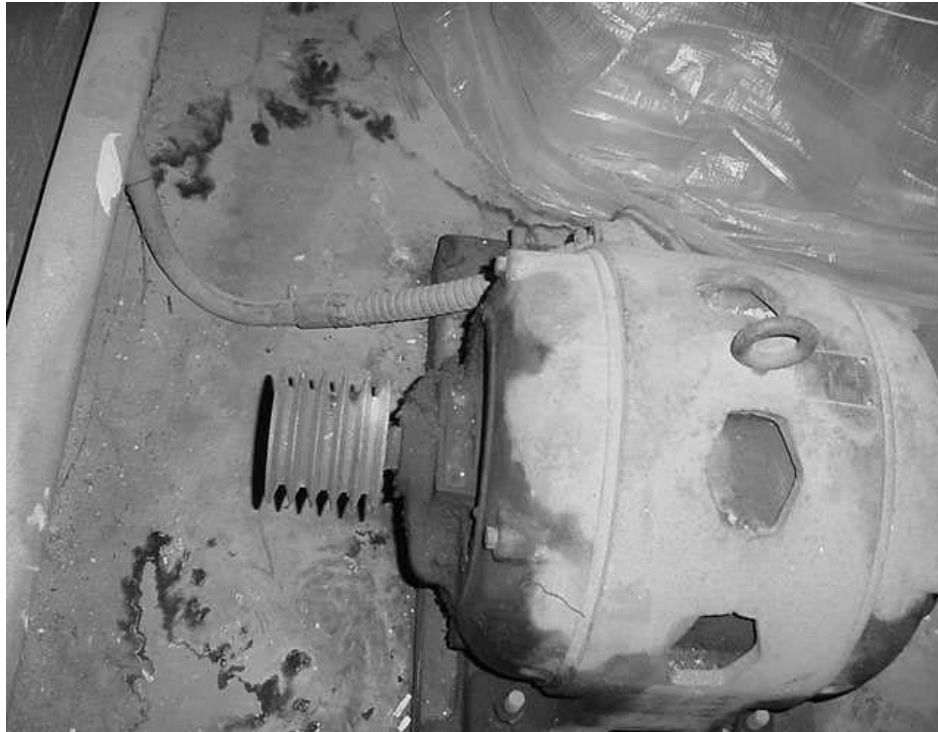
**Picture 9**

**Fan Motor with Fan Belt Removed**

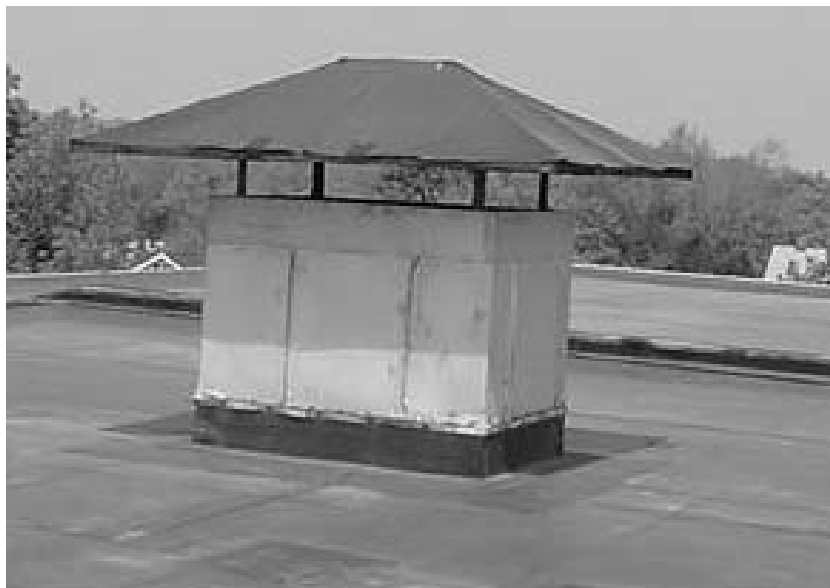
**Picture 10**

Of primary note was the accumulation of possible bird wastes observed inside the exhaust vent system (see Picture 10 and 11). Bird wastes in a building raise concerns over diseases that may be caused by exposure to bird wastes. These conditions warrant clean up of bird waste and appropriate disinfection. Certain molds are associated with bird waste and are of concern for immune compromised individuals. Diseases of the respiratory tract may also result from exposure to bird waste. Exposure to bird wastes is thought to be associated with the development of hypersensitivity pneumonitis in some individuals. Psittacosis (bird fancier's disease) is another condition closely associated with exposure to bird wastes in bird raising and other occupational settings. While immune compromised individuals have an increased risk of health impacts following exposure to the materials in bird wastes, these impacts may also occur in healthy individuals exposed to these materials.

**Exhaust Vent on Roof, Note Lack of Wire Screens to Prevent Pest Entrance**

1. Clean wastes from the exhaust vents on roof.
2. Install wire around openings of exhaust vents to prevent bird/bat roosting.
3. Repair windows to allow for easy opening and closing by occupants. Use open windows to provide fresh air as needed.
4. Close all access doors in abandoned ductwork and crawlspaces.
5. Render airtight all holes/seams in ductwork.
6. Reseal all fresh air supply vents with plywood.

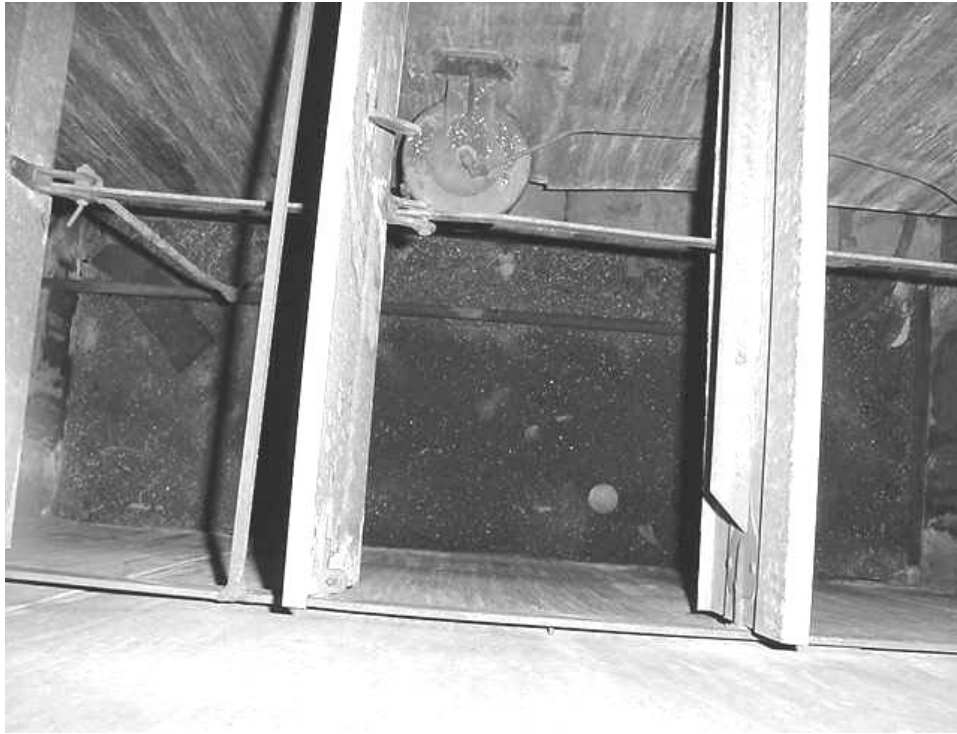
**Picture 11**

**Accumulated Materials At Base Of Exhaust Vent Joints, Note Louvers Are In A Fixed Open Position**

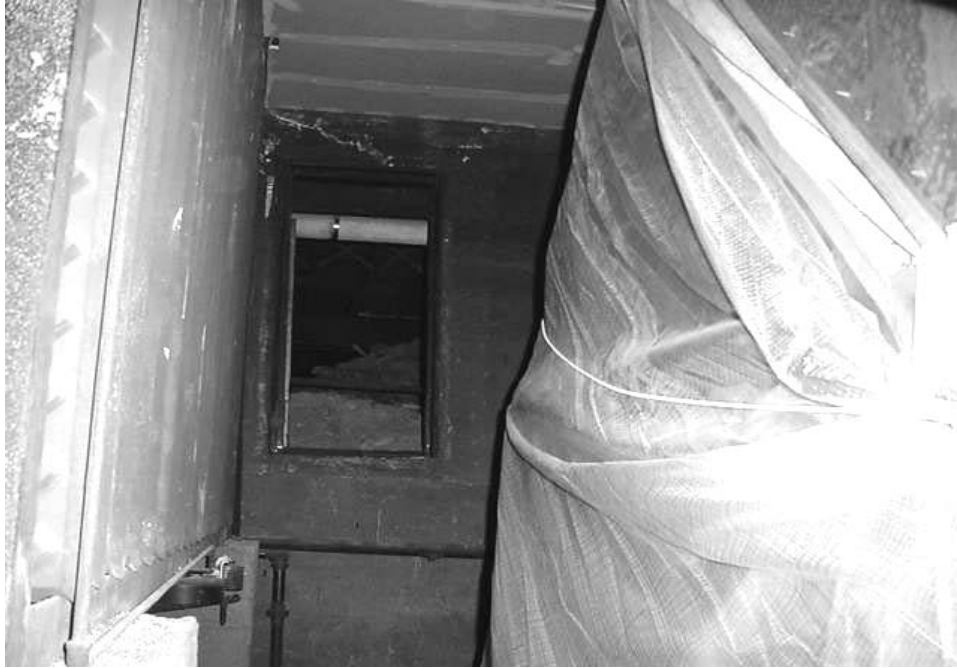
**Picture 12**

The abandoned ventilation system can also serve as a pathway for basement particulates and odors to migrate into occupied areas of the 1926 section. In general, cold air migrates to areas with heated air, thereby creating drafts. The temperature in the heating coil room will generally be lesser than the occupied areas of classrooms, therefore colder basement air will move to classrooms via the vent system if means of access (holes, open access doors) exist in the ductwork. In this instance, pathways for basement air, odors and particulate matter exist. An access door to the vent system was open in the ductwork (see Picture 12). An access door to the 1926 section crawlspace was open inside the fan room (see Picture 13). In addition, holes in ductwork inside the

**Open Duct Access Door in AHU Room in Basement**

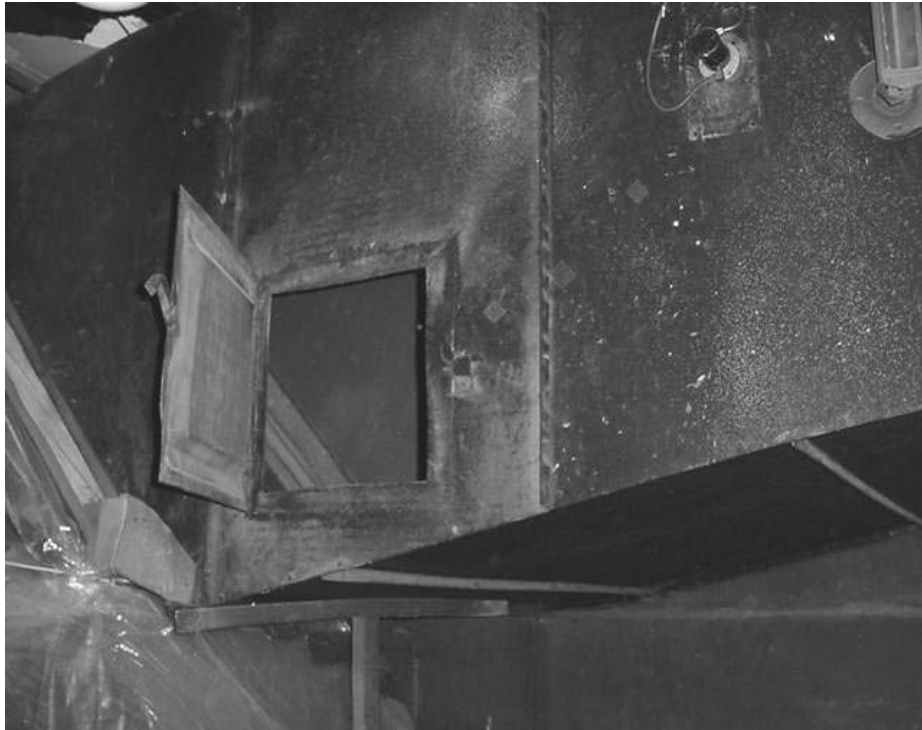
**Picture 13**

dirt crawlspace beneath the 1926 section were also observed. With the removal of plywood sealing each fresh air vent, a pathway for crawlspace pollutants to migrate into classrooms has been established.

**Open Crawlspace Access Door in AHU Room**

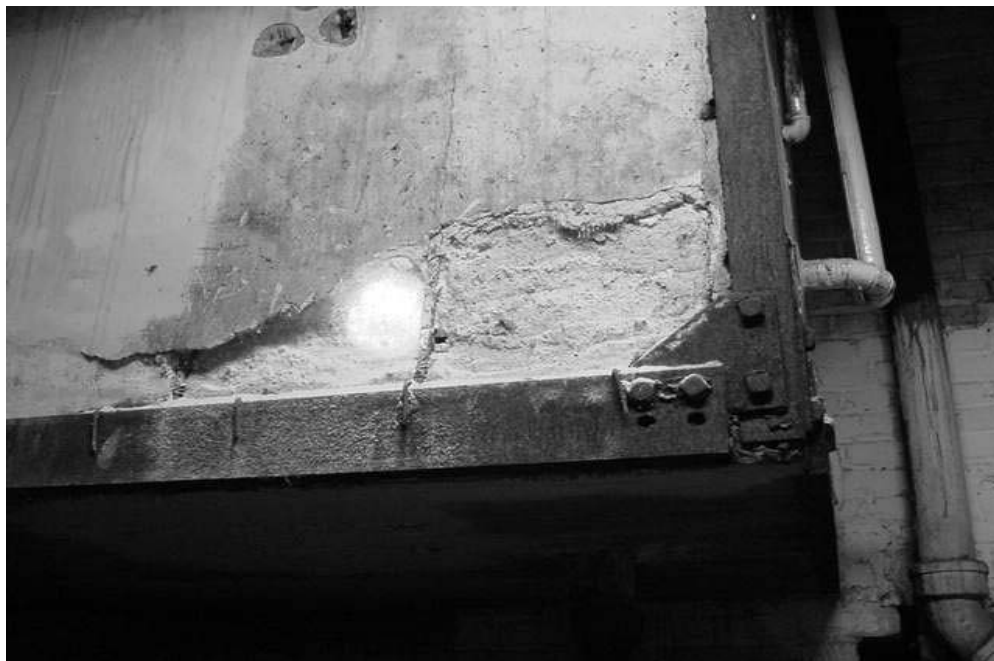
**Picture 14**

A wall that consists of a white, powdered material was found in the basement (see Picture 14). The material may contain asbestos and should be remediated in conformance with all applicable Massachusetts asbestos abatement and hazardous materials disposal laws.

**Wall Material with Damage in Basement**

12. Seal the counter/backsplash seams with caulking to prevent water penetration around sinks.
13. Consider installing local exhaust ventilation in the photocopier area.
14. Ascertain whether material shown in Picture 14, contains asbestos and encapsulate or remove in conformance with Massachusetts law.
